# Evaluation Study Comparing Oil Sheens vs. Bio Sheens

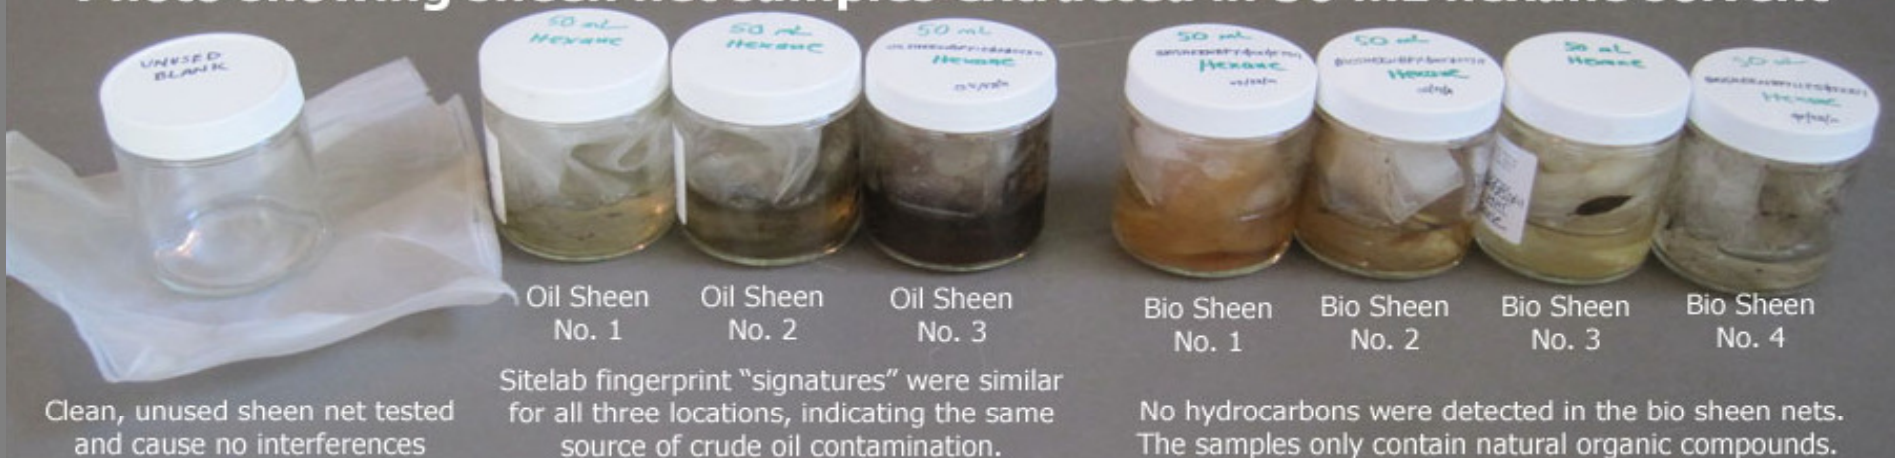
## Photo showing sheen net samples extracted in 50 mL hexane solvent

Clean, unused sheen net tested and cause no interferences

No hydrocarbons were detected in the bio sheen nets. The samples only contain natural organic compounds.

Sitelab fingerprint "signatures" were similar for all three locations, indicating the same source of crude oil contamination.
